Inspection Report

Property Address:
1086 Anyplace Road
Anywhere NC 27537

Cornerstone Residential Inspections, LLC.

Date: 10/1/2013	Time: 11:05 AM	Report ID: 100113421N
Property: 1086 Anyplace Road Anywhere NC 27537	Customer: John Doe	Real Estate Professional:

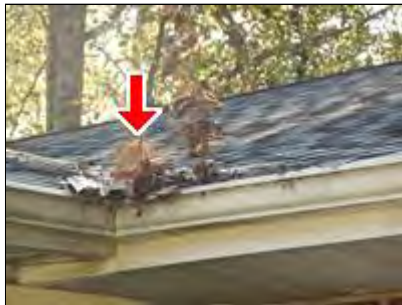
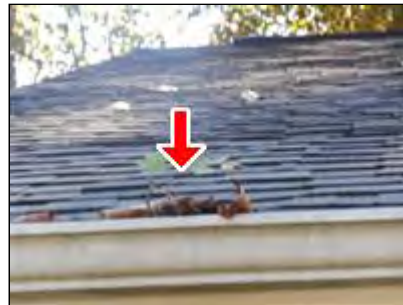
The gutters are full of debris in areas and needs to be cleaned. The debris in gutters can also conceal rust, deterioration or leaks that are not visible until cleaned, and I am unable to determine if such conditions exist.

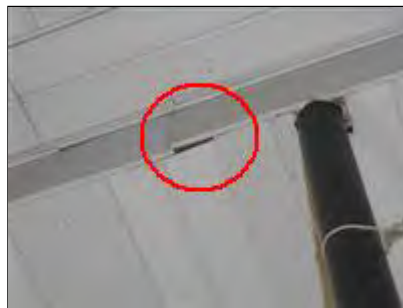
2.5 Picture 1

There is an exposed area where the soffit material at the rear of the house. Have the area properly sealed to eliminated insect intrusion.

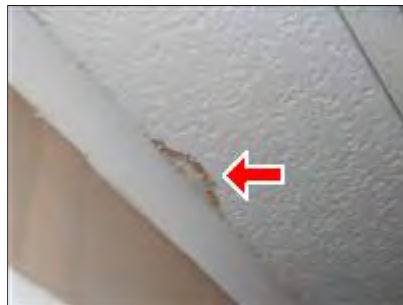
3.0 Picture 1

The Ceiling Tile on the ceiling reveals a light stain which appears from a water leak. Stain appears old at the hallway. This is a cosmetic issue for your information. I recommend repair as desired.

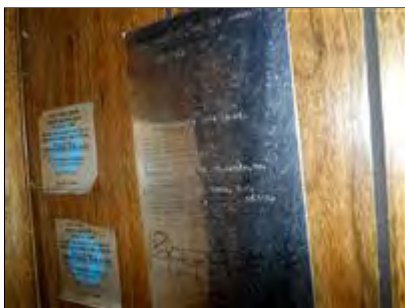
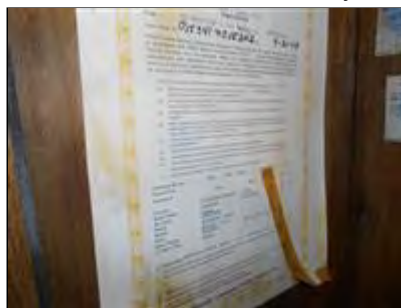
The identification tags for the mobile home are located in the bedroom closet. This is for you information.

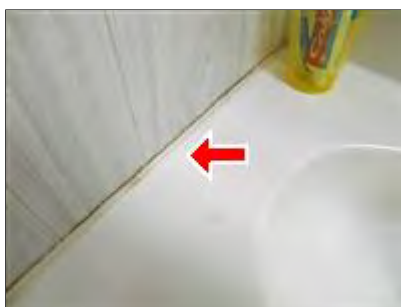
3.4 Picture 1

Have the area at the side splash in the bathroom caulked and sealed to eliminate possible moisture intrusion.

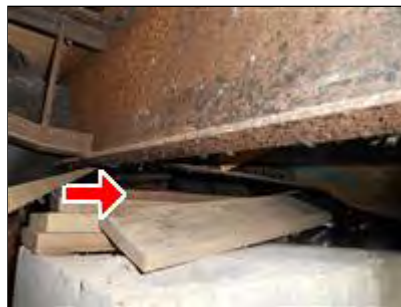
4.0 Picture 1

The wood shims at the structure in the crawlspace are loose and are not properly supporting the structure. Have the shims properly installed.

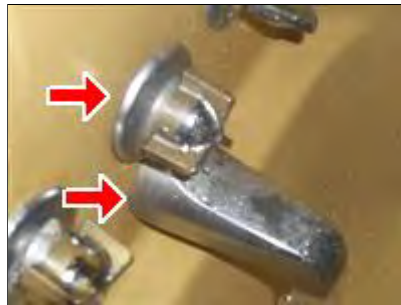
5.1 Picture 1

Have the area around the tub spout and backing plate where it meets the wall at the bathroom, caulked and sealed. Have a qualified person, caulk and seal the spout to eliminate possible water intrusion.

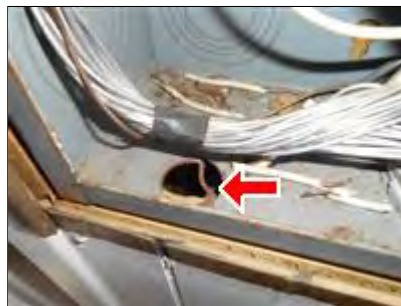
6.1 Picture 1

(1) There is knock out missing in the bottom of the electrical panel box. This has created a hole that needs to have a plug installed. This is a safety issue that needs to be corrected by a qualified person.

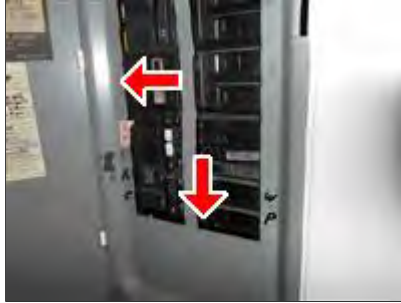
6.1 Picture 2

(2) The panel cover does not fit securely to the panel box. The trim is holding the cover away from the panel box, leaving gaps at the breakers. Have the trim notched to allow the cover to fit securely against the box.

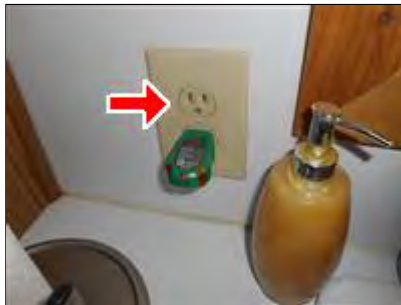
6.3 Picture 1

(1) The electrical outlet at the left of the kitchen sink has an open ground and is wired improperly. This is a safety issue that needs to be corrected. Have a qualified electrician repair as needed.

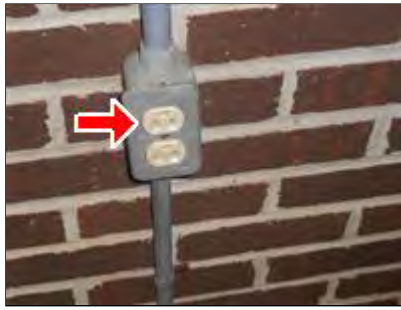
6.3 Picture 3

(3) The outlet at the rear deck is missing a weatherproof cover. Have cover installed for safety.

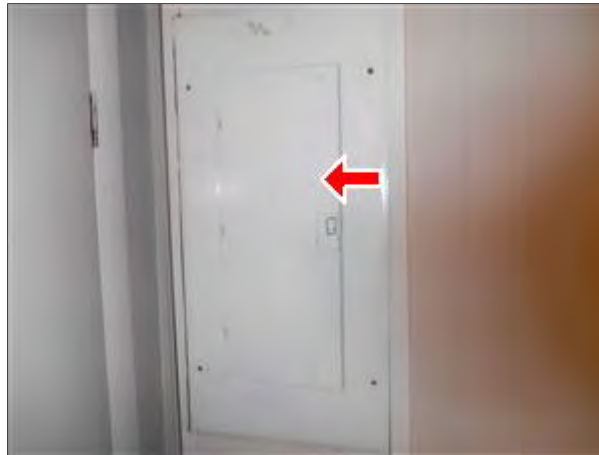
6.6 Picture 1

The main panel box is located at the bedroom.

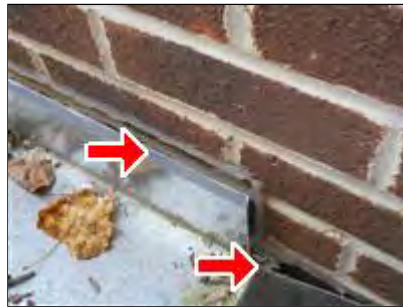
7.0 Picture 1

(1) The metal shroud at the gas pack unit is loose and not properly sealed at the exterior wall. Have the shroud properly secured and sealed by a qualified person.

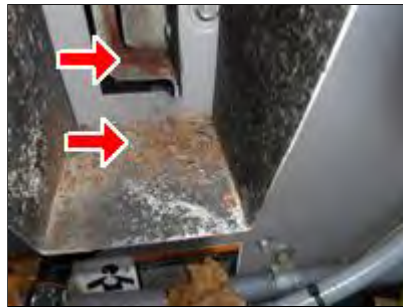
7.0 Picture 2

(2) There is evidence of rust and debris at the gas pack furnace vent. Have the unit serviced by an HVAC contractor to evaluate the burner and heat exchanger area of the unit.

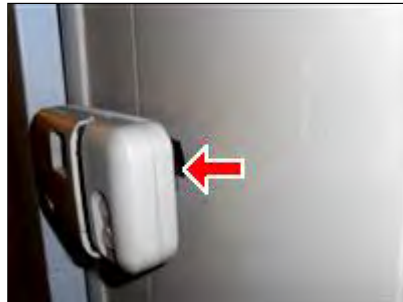
7.1 Picture 1

The thermostat is mounted to the wall with spacers. Have blocking installed to properly secure the thermostat.

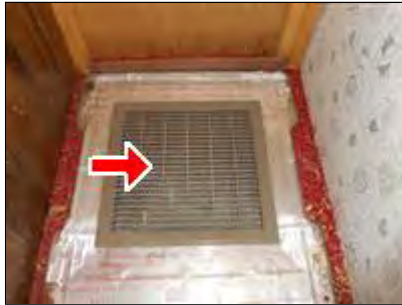
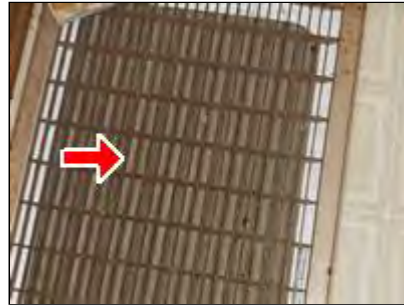
(1) The disposable filter is clogged and is dirty. The filter needs to be replaced. I recommend repair or replace as needed using a qualified person. There are two filter returns in the floor, one in the hall closet and one in the kitchen.

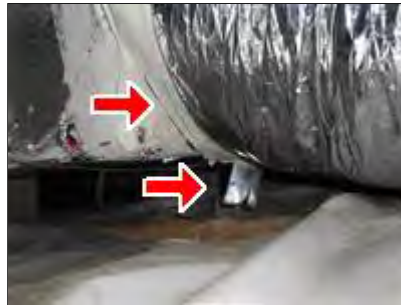
7.3 Picture 3

(2) There is duct tape that is pulling loose at the main duct in the crawlspace. This may lead to lose of heat or cold air. Have the duct properly sealed by a qualified person.

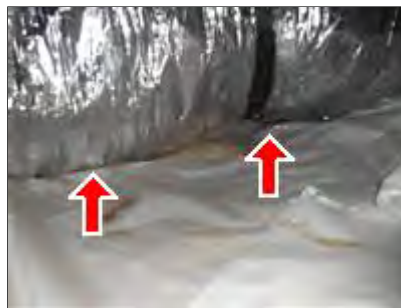
7.3 Picture 4

(3) The main duct is laying on the ground in the crawlspace. This may lead to deterioration of the duct. Recommend having the duct secured to raise the duct from ground contact.

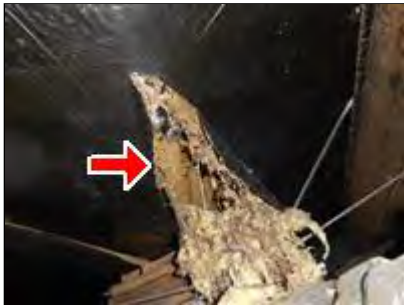
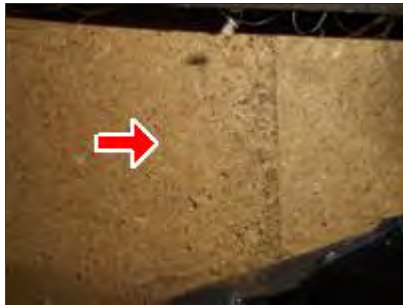
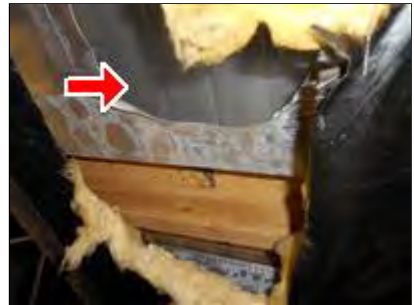
There are several areas where the insulation is damaged or missing in the crawlspace. Have a qualified person repair or replace the damage or missing insulation as needed. There is a section of the old vent duct that is exposed as well. Have the duct sealed and the area insulated.

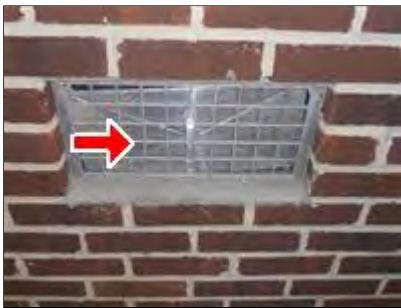
8.3 Picture 1

Recommend opening the foundation vents in the early spring and close in the late fall.

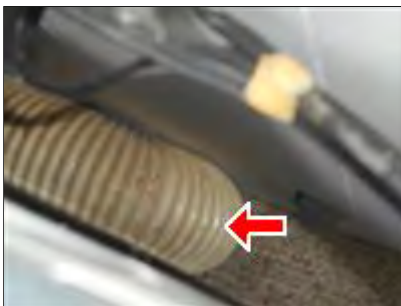
8.4 Picture 1

Recommend replacing the vinyl dryer duct with rigid or flexible metal duct. This is for your information.

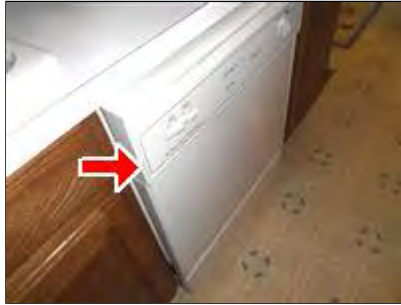
9.0 Picture 1

The dishwasher would not properly drain during operation. Have dishwasher evaluated by a qualified person and repair as needed.

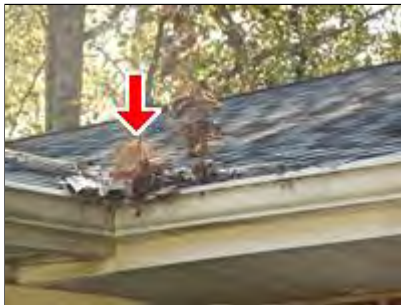
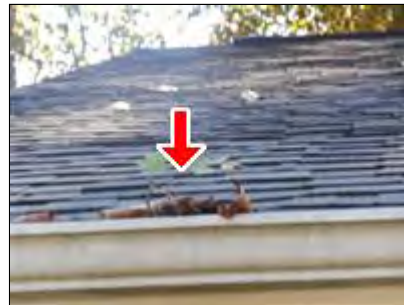
The gutters are full of debris in areas and needs to be cleaned. The debris in gutters can also conceal rust, deterioration or leaks that are not visible until cleaned, and I am unable to determine if such conditions exist.

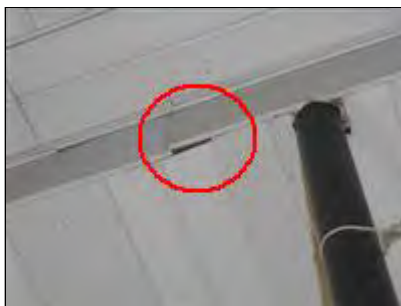
2.5 Picture 1

There is an exposed area where the soffit material at the rear of the house. Have the area properly sealed to eliminated insect intrusion.

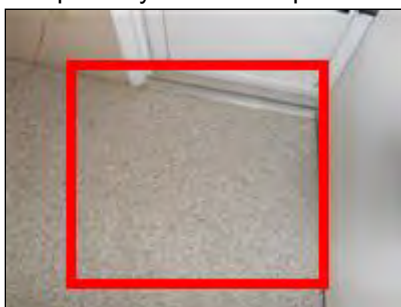
3.2 Picture 1

The flooring at the front door area feels soft. Unable to determine if there is damage underneath to the subfloor, the area underneath in the crawlspace is covered with netting. The under side of the subfloor is not visible. Have a qualified contractor evaluate if concerned. Carpet may need to be pulled back to assure the soundness of the subfloor.

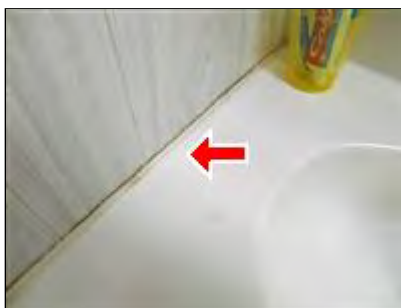
3.4 Picture 1

Have the area at the side splash in the bathroom caulked and sealed to eliminate possible moisture intrusion.

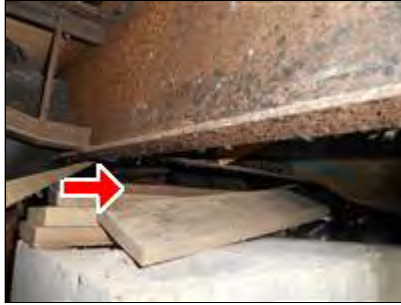
4.0 Picture 1

The wood shims at the structure in the crawlspace are loose and are not properly supporting the structure. Have the shims properly installed.

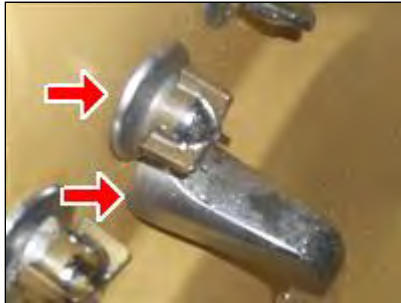
5.1 Picture 1

Have the area around the tub spout and backing plate where it meets the wall at the bathroom, caulked and sealed. Have a qualified person, caulk and seal the spout to eliminate possible water intrusion.

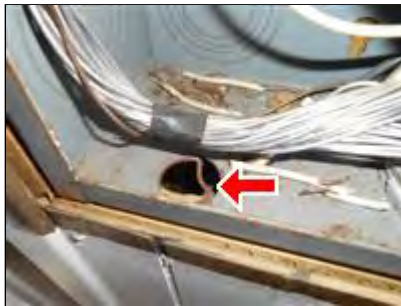
6.1 Picture 1

(1) There is knock out missing in the bottom of the electrical panel box. This has created a hole that needs to have a plug installed. This is a safety issue that needs to be corrected by a qualified person.

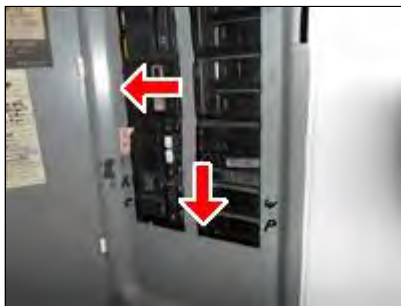
6.1 Picture 2

(2) The panel cover does not fit securely to the panel box. The trim is holding the cover away from the panel box, leaving gaps at the breakers. Have the trim notched to allow the cover to fit securely against the box.

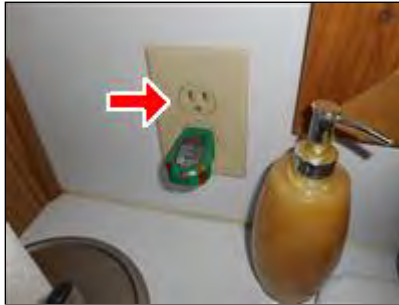
6.3 Picture 1

(1) The electrical outlet at the left of the kitchen sink has an open ground and is wired improperly. This is a safety issue that needs to be corrected. Have a qualified electrician repair as needed.

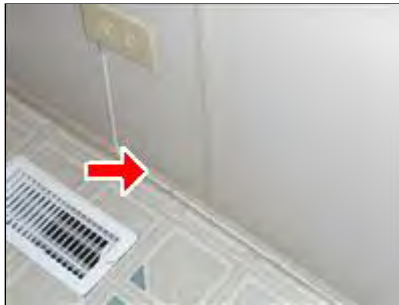
6.3 Picture 2

(2) There is an extension cord that is being used to extend an outlet. The wiring needs to be corrected and installed in conduit. This is a safety issue that needs to be corrected by a qualified electrician.

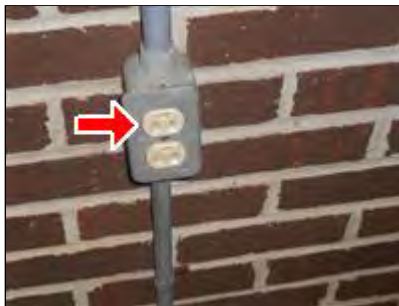
6.3 Picture 3

(3) The outlet at the rear deck is missing a weatherproof cover. Have cover installed for safety.

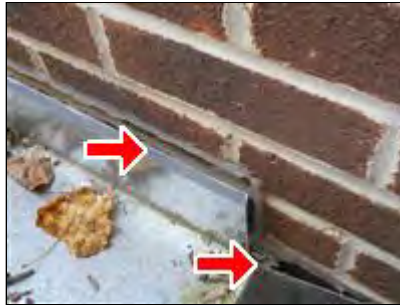
7.0 Picture 1

(1) The metal shroud at the gas pack unit is loose and not properly sealed at the exterior wall. Have the shroud properly secured and sealed by a qualified person.

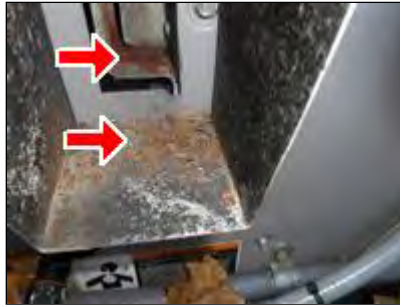
7.0 Picture 2

(2) There is evidence of rust and debris at the gas pack furnace vent. Have the unit serviced by an HVAC contractor to evaluate the burner and heat exchanger area of the unit.

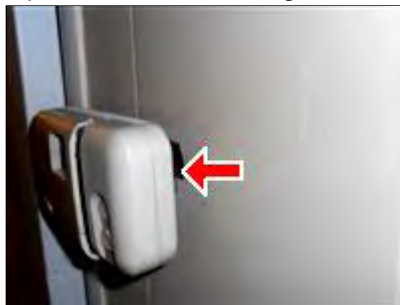
7.1 Picture 1

The thermostat is mounted to the wall with spacers. Have blocking installed to properly secure the thermostat.

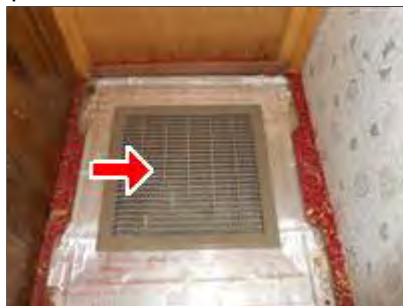
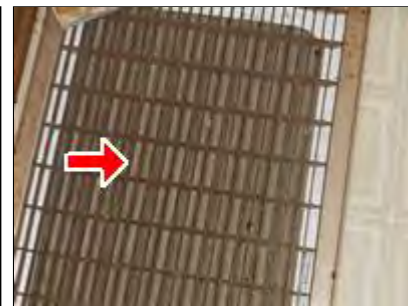
(1) The disposable filter is clogged and is dirty. The filter needs to be replaced. I recommend repair or replace as needed using a qualified person. There are two filter returns in the floor, one in the hall closet and one in the kitchen.

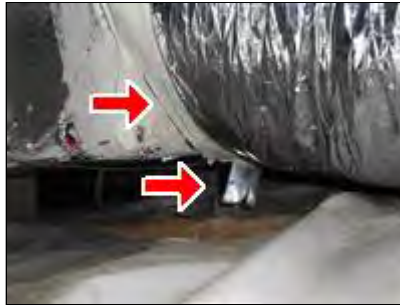
7.3 Picture 3

(2) There is duct tape that is pulling loose at the main duct in the crawlspace. This may lead to lose of heat or cold air. Have the duct properly sealed by a qualified person.

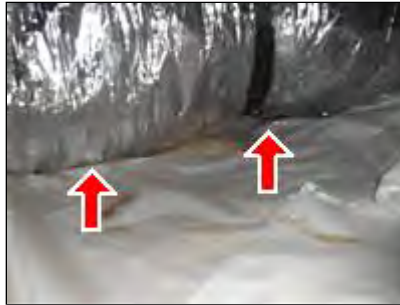
7.3 Picture 4

(3) The main duct is laying on the ground in the crawlspace. This may lead to deterioration of the duct. Recommend having the duct secured to raise the duct from ground contact.

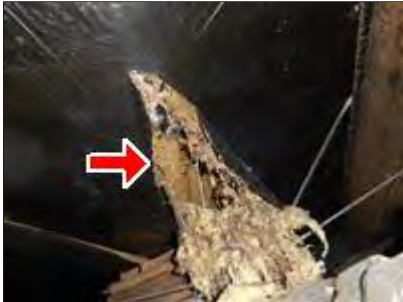
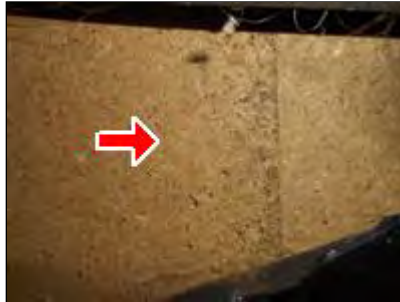
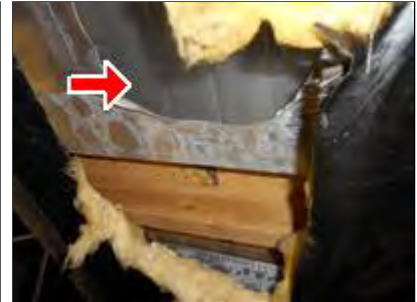
There are several areas where the insulation is damaged or missing in the crawlspace. Have a qualified person repair or replace the damage or missing insulation as needed. There is a section of the old vent duct that is exposed as well. Have the duct sealed and the area insulated.

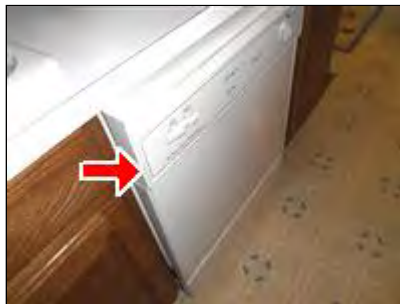
9.0 Picture 1

The dishwasher would not properly drain during operation. Have dishwasher evaluated by a qualified person and repair as needed.
